BUILDING (STRUCTURAL) CONDITION SURVEY

The Former Boars Head Public House, Garstang Road, Barton, Lancashire, PR3 5DR

JOB REF: 5442, DATED: 31/08/2017, VERSION: 1.01

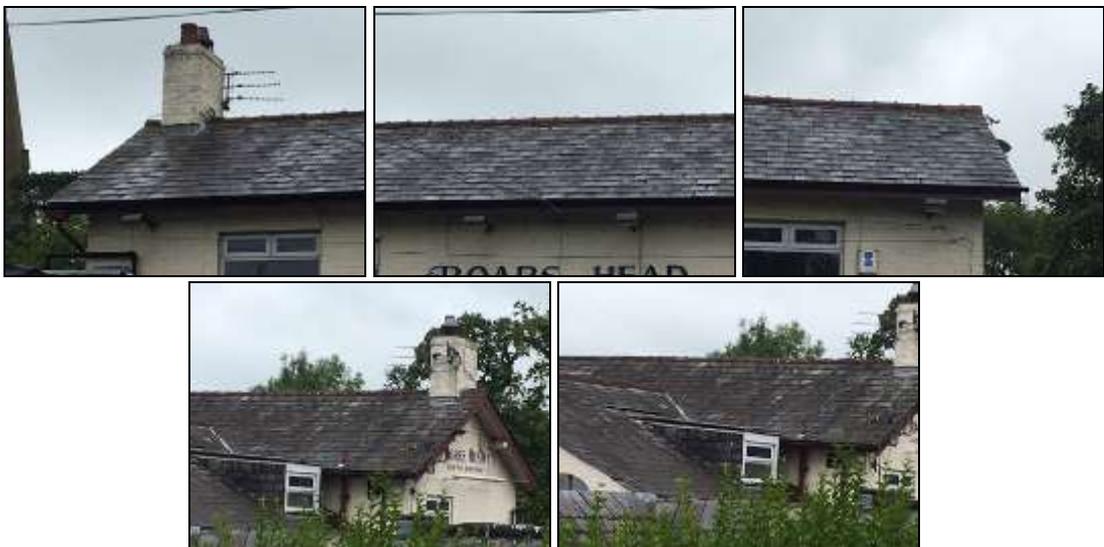
The natural slate roof covering to the main property appeared to be in average to poor condition at the time of inspection which was to be as expected given the age of the property. The natural slate covering illustrated signs of natural weathering throughout (slightly cracked/chipped in places). There did not appear to be any significant dislodged slates, breaches caused by defective coverings when viewed externally on the date of inspection, but remedial re-roofing works are likely to be required.

PL03: Front and rear roof pitches to the original part of the former public house.

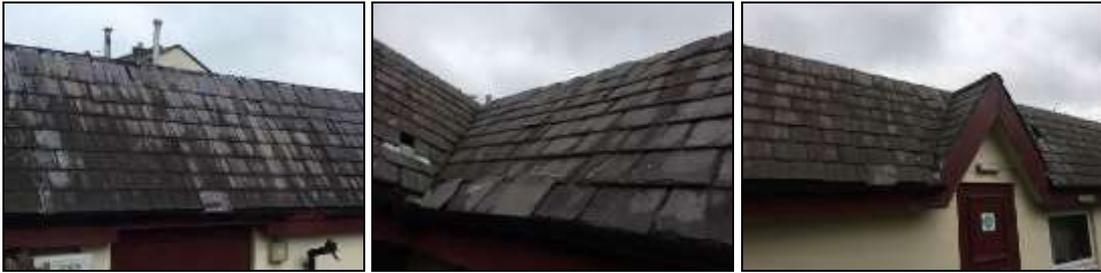
The slate covering to the parapets of the extension roof were in average to poor condition at the time of inspection with a large number of missing and dislodged slates noted throughout, leaving the roof currently vulnerable to internal water ingress. This requires re-roofing in full given the extent of slate dislodgements present.

PL04: Areas of dislodged and missing tiles note throughout the roof to the building.

- Damaged areas of the roof covering should be repaired and all damage slates should be replaced whilst ensuring that the roof is water tight.
- Stolen lead flashings should be replaced throughout.

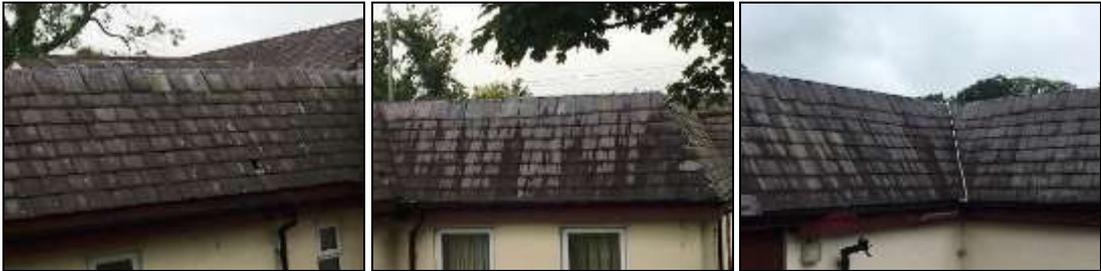
The majority of the lead flashings to the extension roof coverings have been stolen whilst the building has been vacant leading to significant water ingress and will require renewal / reinstating to prevent further water ingress into the building.

PL05: Areas of missing lead flashings to the theft, noted throughout.

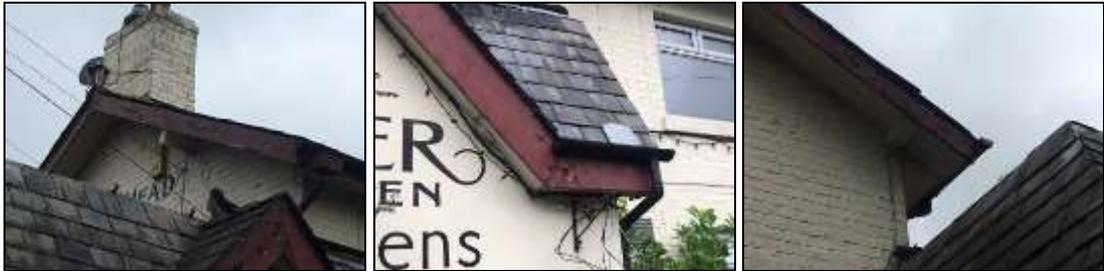
The timber fascia and barge boards were noted as being in poor condition at the time of inspection, with areas of decay and surface finish degradation visible. It is recommended that the external timber replaced and any salvageable sections be cleaned down, re-treated and repainted to prevent any further decay.

PL06: Poor and decaying condition of the external fascia and barge boards.

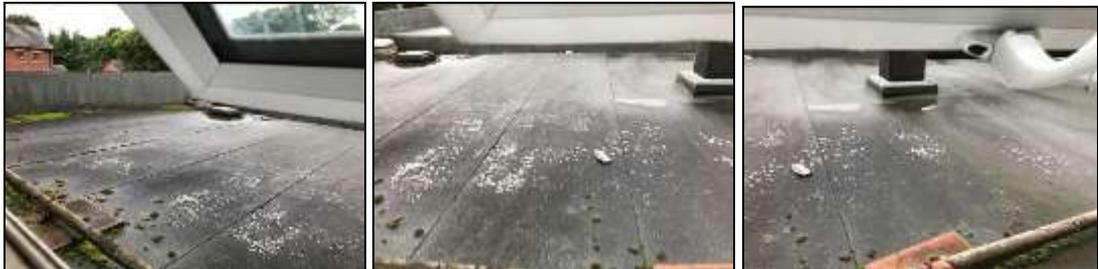
The felt roof covering to the areas of flat roofing appeared to be in very poor condition at the time of inspection with areas of moss / vegetation growth in addition to pooling of surface water. This would suggest that the roof surface and covering are not laid to a sufficient enough fall to enable the efficient discharge of surface water from the roof surface, leading to the accelerated degradation of the roof covering and internal water ingress as a result of defective roof coverings.

It should be noted as with all materials, mineral roofing felt has a limited lifespan of between 10-15 years and the covering had exceeded this lifespan. Given the condition of the roofing felt and the evidence of internal water ingress, full renewal of the roofing felt and under-boarding is required. The replacement of the roof structure is also likely to be required due to suspected further decay / rot, given the extent of surface water ingress present on the date of inspection.

PL07: Poor condition of mineral felt roof covering to an area of the modern flat roof extension.

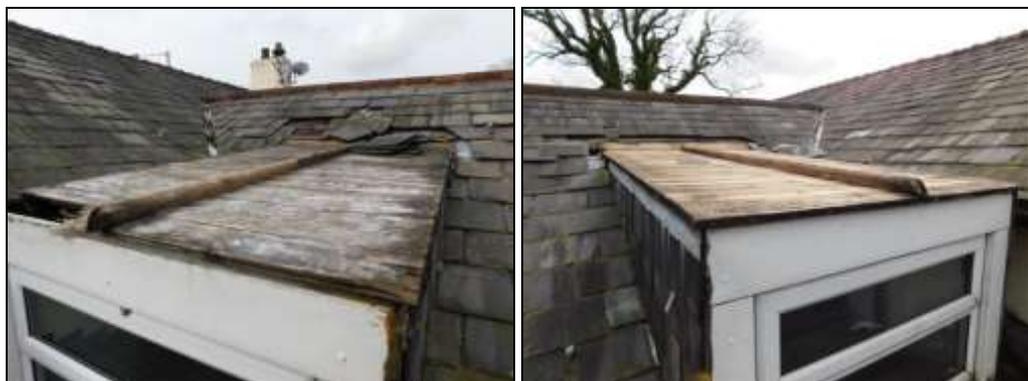
PL08: Poor condition of roofing as a result of suspected theft of lead coverings and flashings.

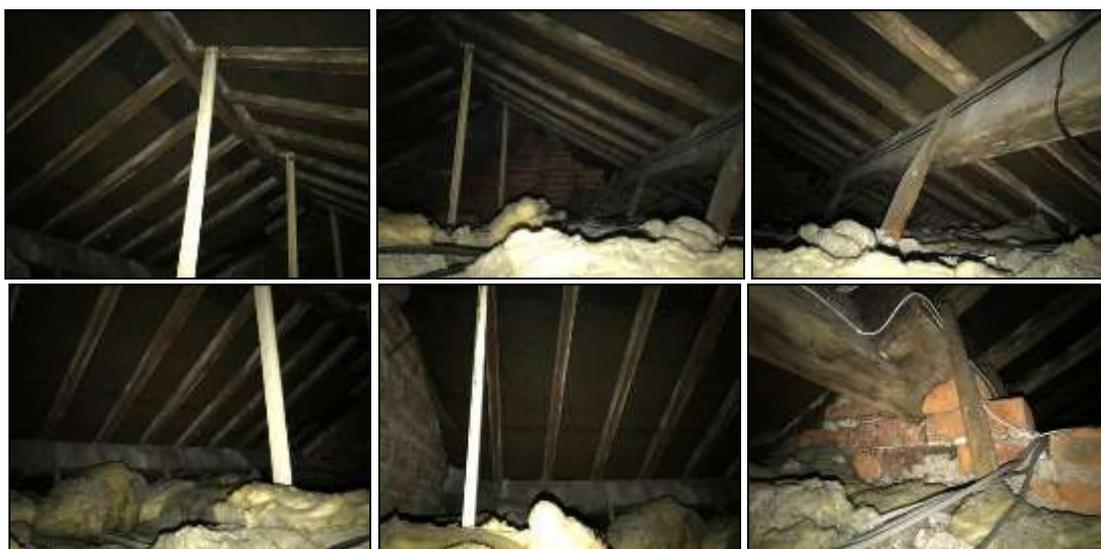
With regards to the original building of the former public house, in buildings of this age it was normal practice for structural members to be embedded within or resting upon masonry supports. In conditions where there is localised damp penetration this will leave timbers susceptible to decay. The building occupier should, therefore, exercise vigilance and routinely inspect where possible. This said, the existing roof is likely to be original, or at least very old. The majority of structural timbers to the inspected roof voids appeared to contain areas of darkening/ decay of the timbers / dampness at the time of inspection. Subsequently, It is recommended to treat all timbers, as a precautionary measure as part of any future remedial re-roofing works in order to prevent/limit any further deterioration from occurring.

PL09: Condition of an area of roof structure above the original historic section of the building.

- Remedial works should be carried out to the timber roof structure where required following areas of water ingress. This may consist of the replacing areas of decayed roof structure (following opening up) and treating of all timber components that are to be retained.

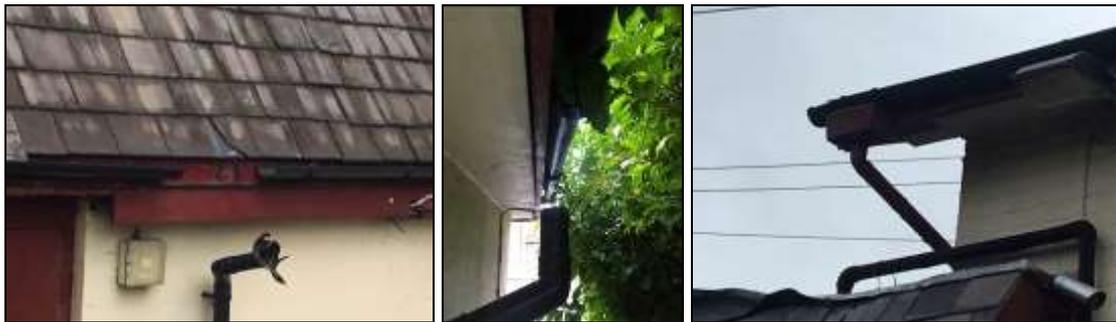
The existing rainwater goods appeared to be slightly aged and in poor condition at the time of inspection. Dislodgements and damage was noted throughout which has led to the uncontrolled discharge of surface water at these locations. There is the potential to salvage and reuse areas of the existing rainwater goods, but it is potentially more cost effective to replace in full.

PL10: Poor / damaged condition of rainwater goods noted throughout.

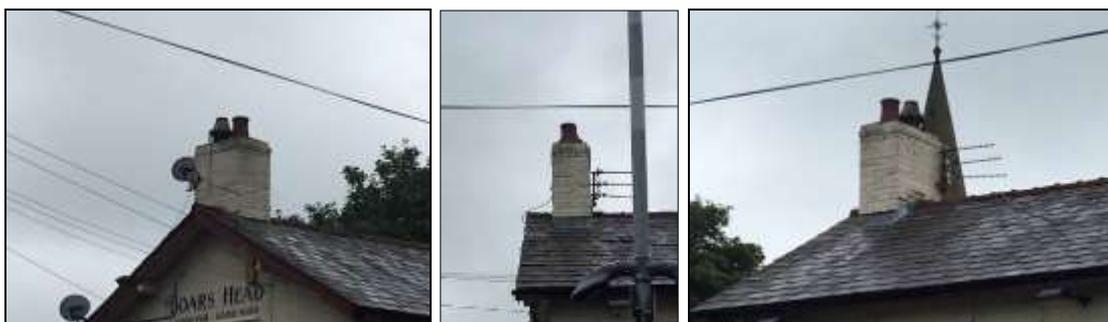
Chimney stack appeared to be in average condition; however a very marginal lean was noted to the chimney stack and appeared to be leaning slightly towards the north. This is likely to have been caused as a result of the chimneys' orientation and the effects of the weather over time. It is recommended, as a precautionary measure, to check for signs of any further movement of the chimney.

The lead flashings appeared to be in average to poor condition at the time of inspection but with no obvious significant issues of note. Weathering and discolouring of the flashings was noted, but all this being said, on internal inspection, there was no obvious evidence of internal water ingress that could have occurred as a result of defective flashings to this location.

PL11: Existing chimney stack to the north side of the original public house.

The masonry appeared to be sound at the time of inspection however; a paint finish concealed the exact condition of the masonry at the time of inspection. It is recommended that the chimney be inspected closely on erection of a safe working platform to fully confirm the exact condition of the masonry and mortar.

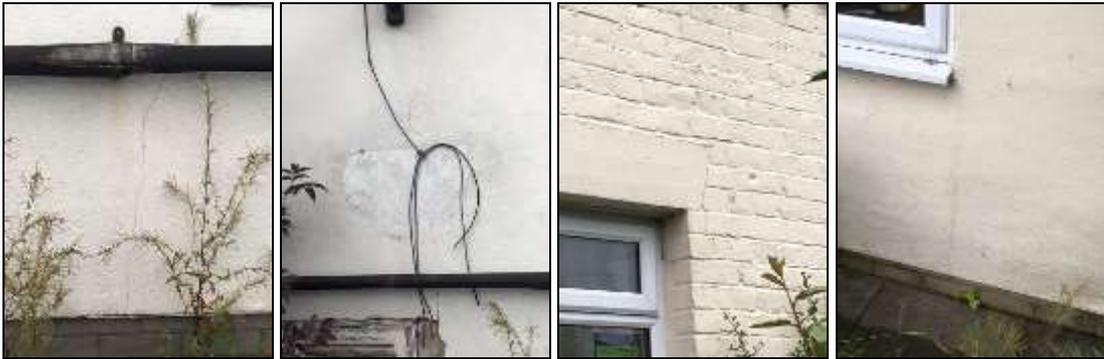
This being said, the external finishes were in poor condition. Render finishes were cracked and exhibiting evidence of degradation, compromising long term weather tightness. Raking out and repointing of masonry at low level would also be required due to mortar degradation, in order to prevent further degradation and internal water ingress.

PL12: Cracking present throughout the external walls of the building.

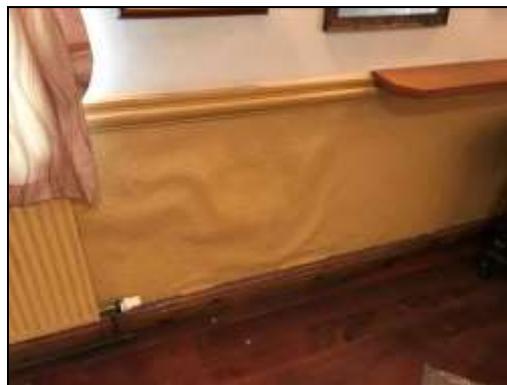
Internal dampness was evident within the building through the presence of damage to internal wall finishes. This would suggest that the building (original building) may not possess a method of DPC i.e. slate, due to its age, and being of solid wall construction, would be

susceptible to increasing levels of damp transfer. A new system would require retrofitting involving an injection DPC / internal water proofing / tanking system throughout.

PL13: Evidence of internal dampness and decorative damage noted internally throughout the building.

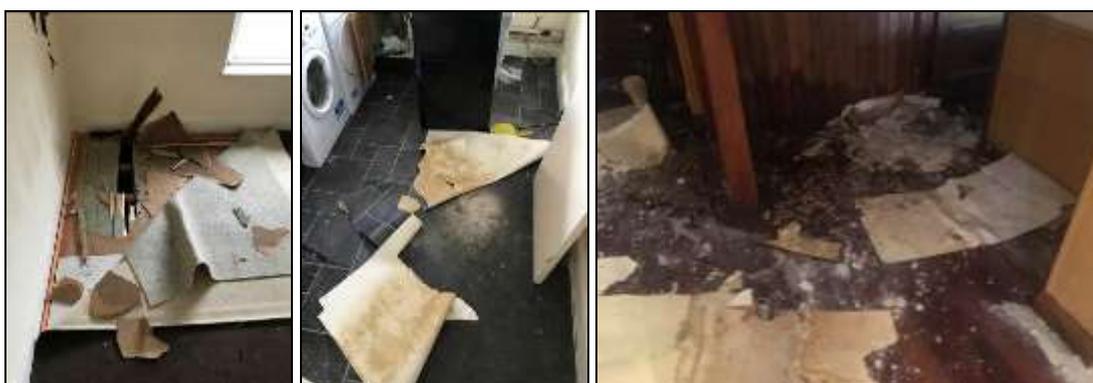
The floor finishes throughout appeared to be extremely poor and damaged. Full reinstatement will be required.

PL14: Evidence indicative of damage to floor finishes throughout the building.

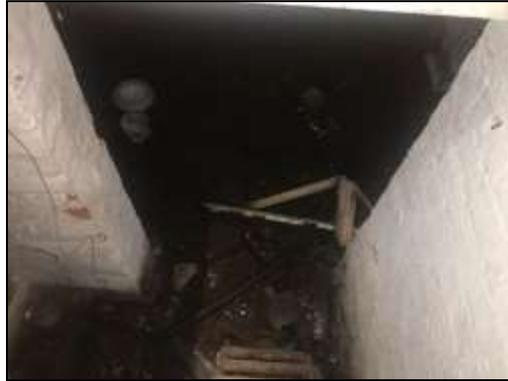
Within the basement, evidence of water penetration / ingress was noted throughout and a DPM installation and tanking system will be required in order to fully waterproof the walls and floor of the basement. This space was uninhabitable and unsuitable for any use at the time of survey.

PL15: Evidence of internal dampness to the walls and floor of the basement.

- Internal tanking system installation to existing cellar.
- Existing ground floor to cellar should be grubbed up and replaced with a new insulated concrete ground floor structure incorporating DPMs with DPCs lapped up to new tanking system.

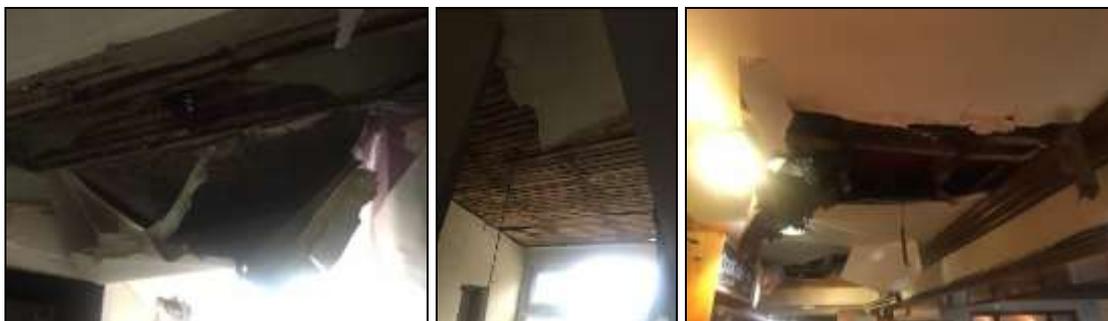
Ceilings appeared to be in very poor condition throughout with areas of collapsed ceiling and damage to internal ceiling finishes all caused as a result of water ingress at roof level. Full reinstatement of ceilings will be required.

PL16: Poor condition of ceilings throughout the building.

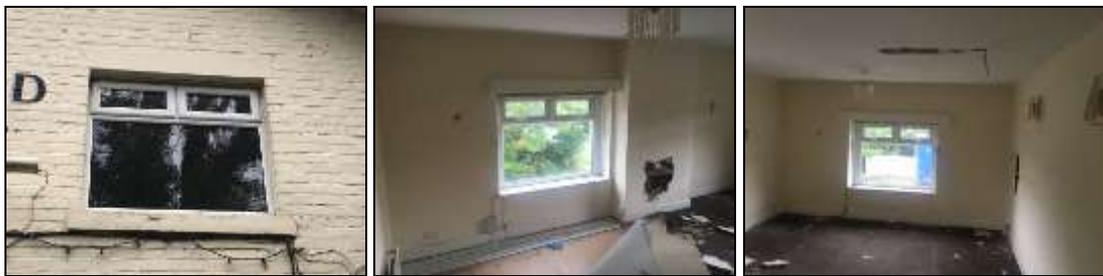
All windows generally appeared in average condition at the time of inspection. All double glazed units' appeared sound including mastic seals (average condition, renewal recommended in future) with no condensing or internal steaming of glass panes noted at the time of. Windows and doors appeared slightly dated at the time of inspection. No misting was noted to doors at the time of inspection. Minor soiling noted to windows and doors throughout.

PL17: uPVC windows present throughout the property.

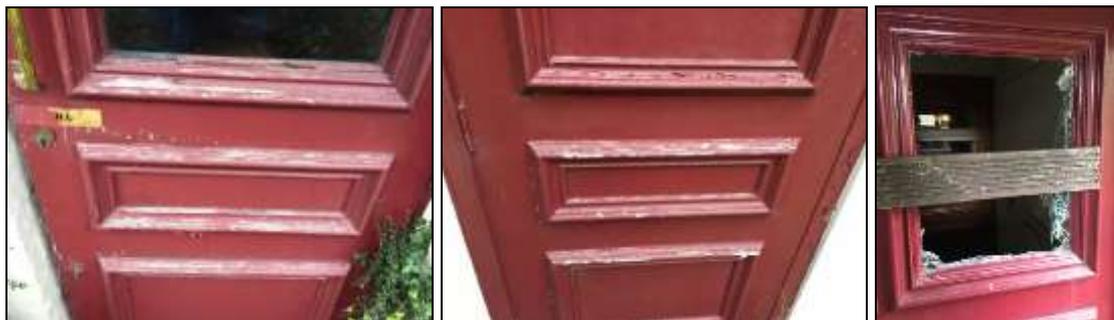
Doors were noted as being in poor condition at the time of inspection with areas of decay noted throughout. Isolated glazing panes were also noted as damaged throughout. The doors had also been fixed closed to prevent trespassing which itself will cause damage to the doors both internally and externally to the building. Overhaul or replacement of the existing doors is recommended.

PL 18: Indicating decay and damage to doors noted at the time of inspection.

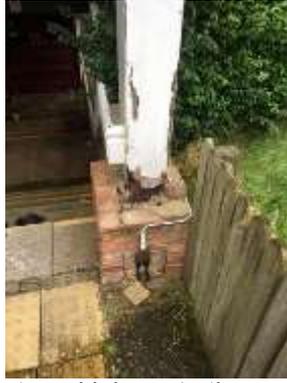
PL19: Area of decayed external joinery to the rear entrance of the building.

- Installation of isolated areas of replacement floors.
- Overhaul / replacement of existing external joinery items and doors (internally and externally).
