## **BUILDING (STRUCTURAL) CONDITION SURVEY**

In connection with The Former Boars Head Public House,  
Garstang Road, Barton, Lancashire, PR3 5DR

**JOB REF: 5442, DATED: 08/08/2019, VERSION: 1.01**

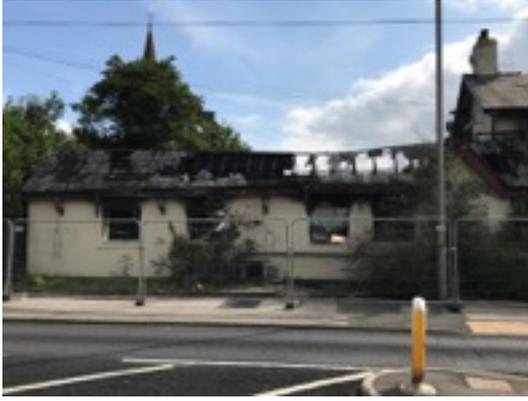
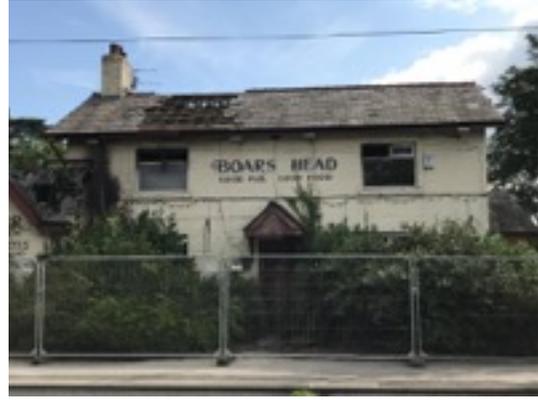
*PL03: Illustrating extent of fire spread and damage caused to the front of the existing premises on viewing from Garstang Road.*

It is recommended that the whole building be demolished as a matter of some considerable urgency.

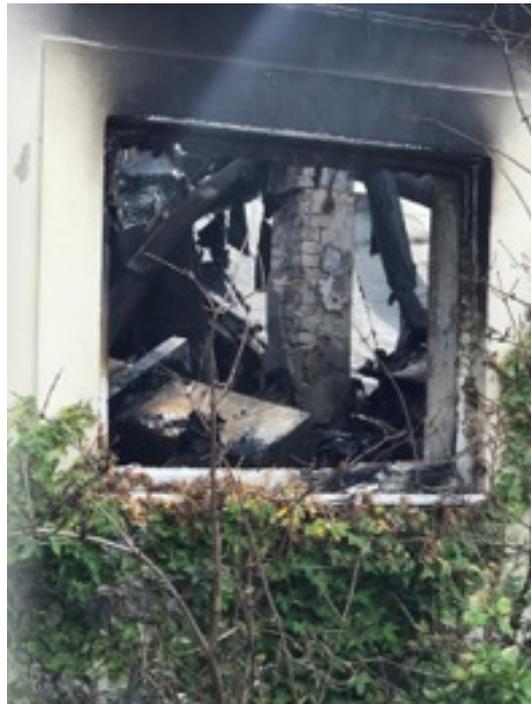
*PL03: Illustrating extent of fire damage to section of masonry structural pier currently holding up steel UB supports damaged by high temperatures.*

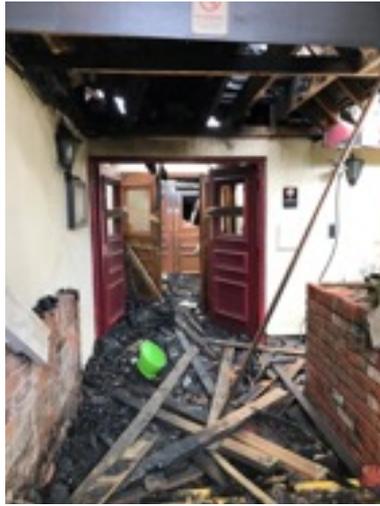
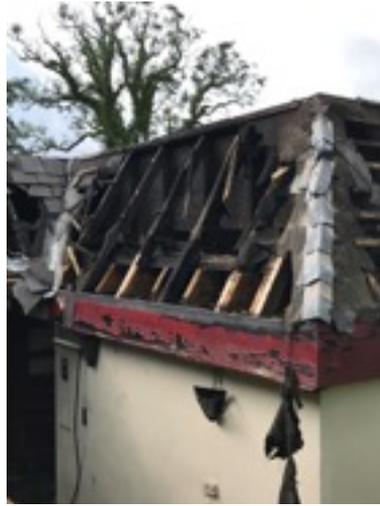
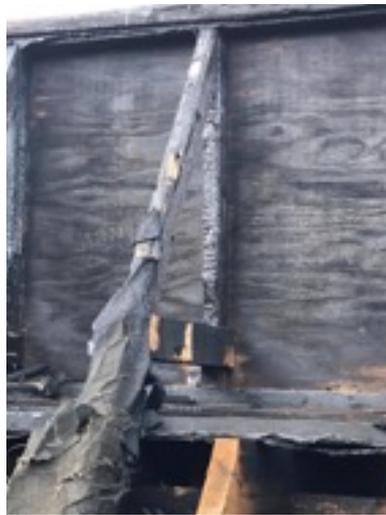
*PL04: Illustrating general extent of debris present throughout the property following the fire damage having occurred. The structural integrity of remaining timber roof and suspended timber first floor constructions cannot be guaranteed and retained. Where remaining in-situ timbers illustrating significant signs weakening, char and associated damage.*

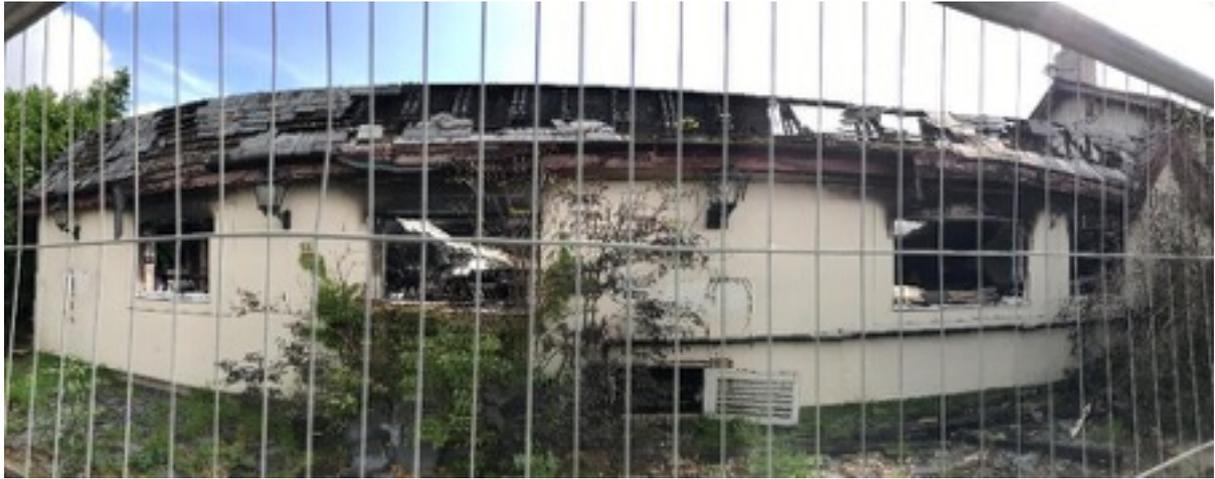
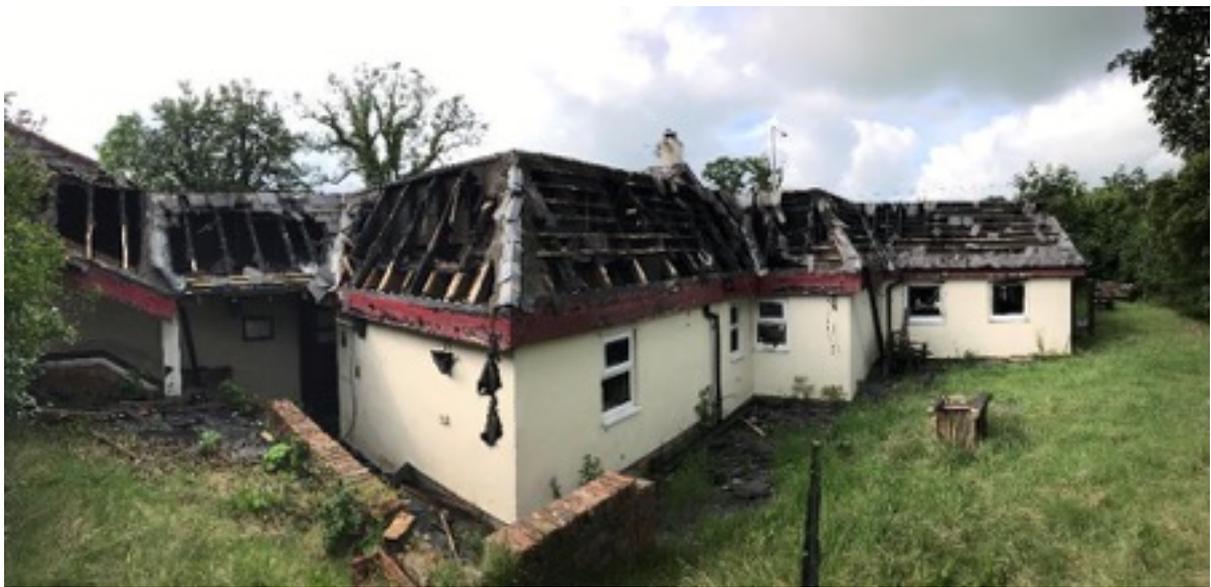
*PL05: Illustrating extent of fire damage to external building elements of the single storey section of the former Boars Head premises recorded on the date of inspection. Significant risk of further collapse causing injury or death likely.*

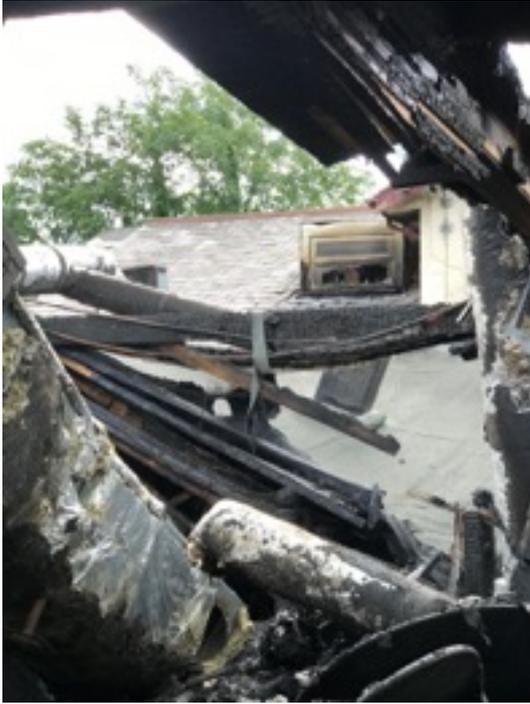
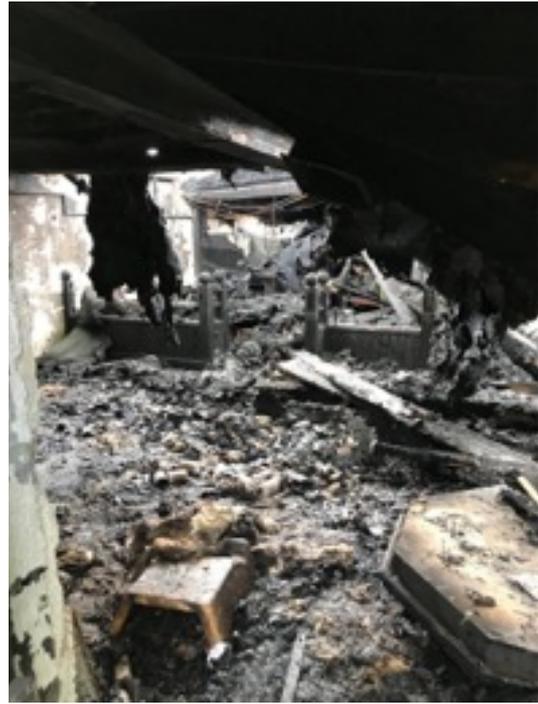
*PL. 06: Illustrating extent of fire damage to internal building elements of the single storey section of the former Boars Head premises recorded on the date of inspection. Significant risk of further collapse causing injury or death likely (photos 1 of 4).*

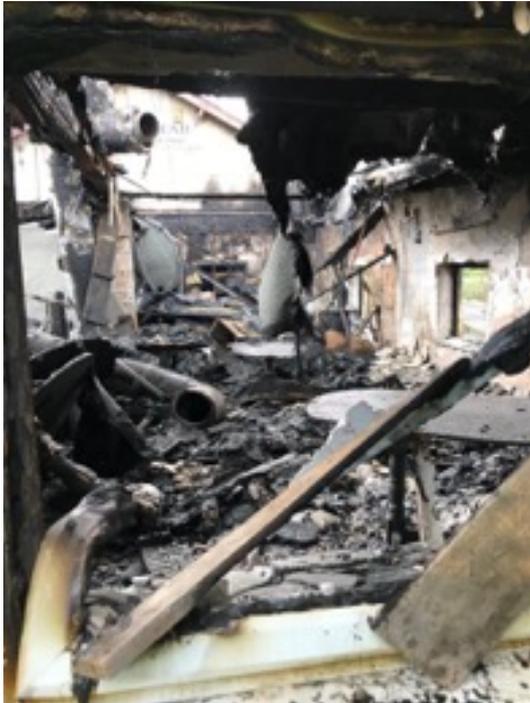
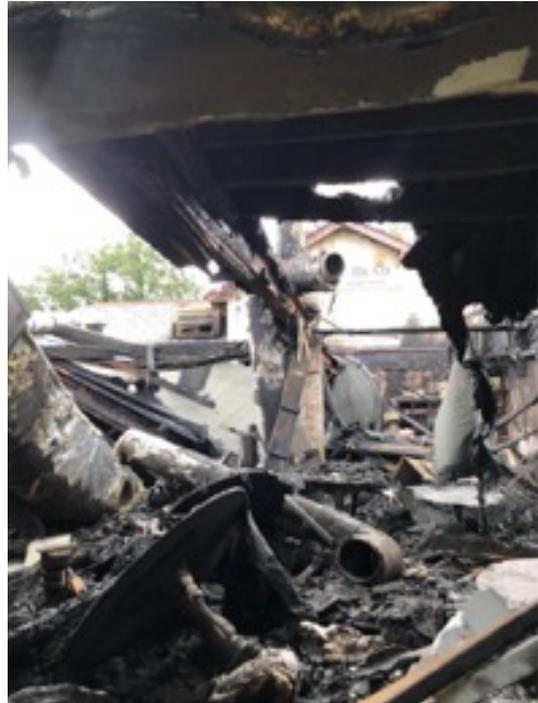
*PL. 07: Illustrating extent of fire damage to internal building elements of the single storey section of the former Boars Head premises recorded on the date of inspection. Significant risk of further collapse causing injury or death likely (photos 2 of 4).*

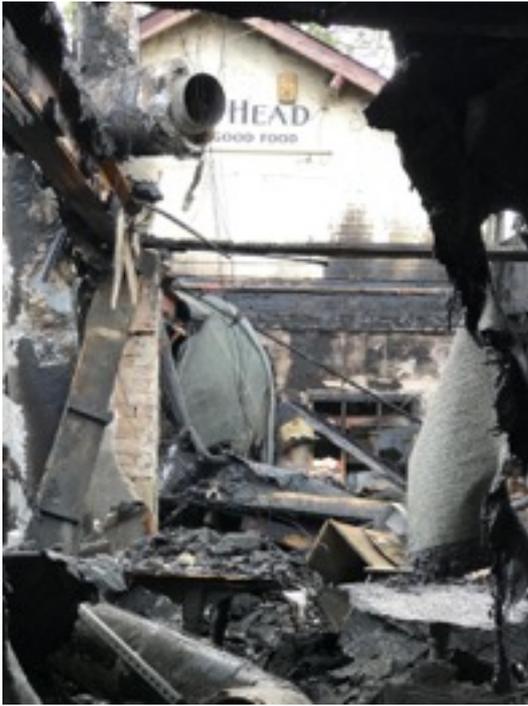
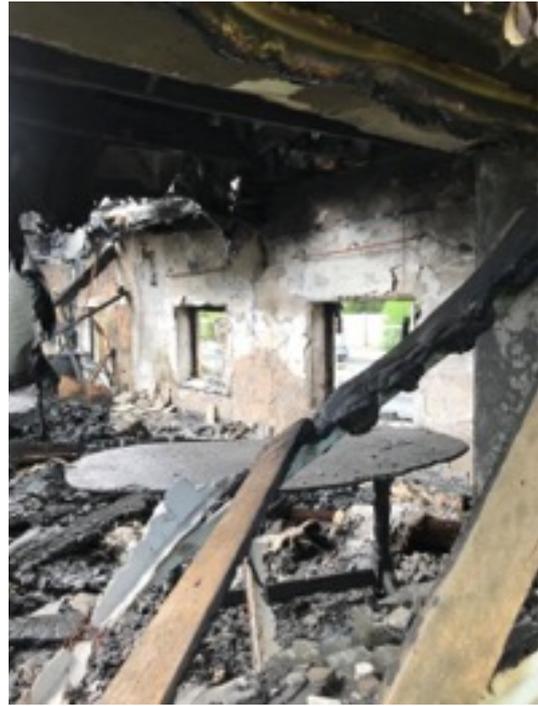
*PL. 08: Illustrating extent of fire damage to internal building elements of the single storey section of the former Boars Head premises recorded on the date of inspection. Significant risk of further collapse causing injury or death likely (photos 3 of 4).*

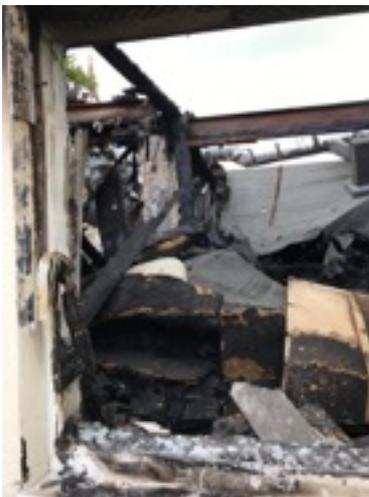
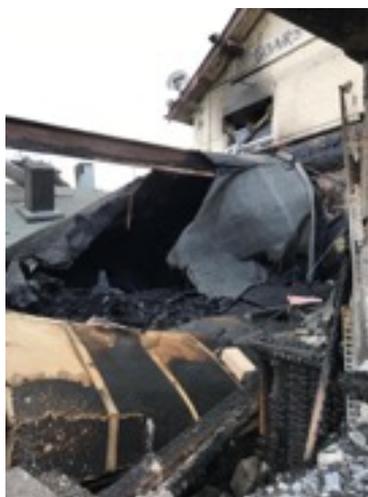
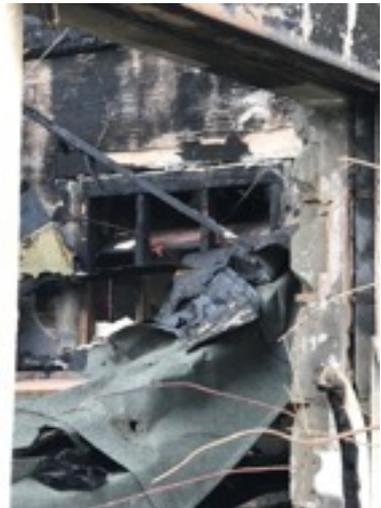
*PL. 09: Illustrating extent of fire damage to internal building elements of the single storey section of the former Boars Head premises recorded on the date of inspection. Significant risk of further collapse causing injury or death likely (photos 4 of 4).*

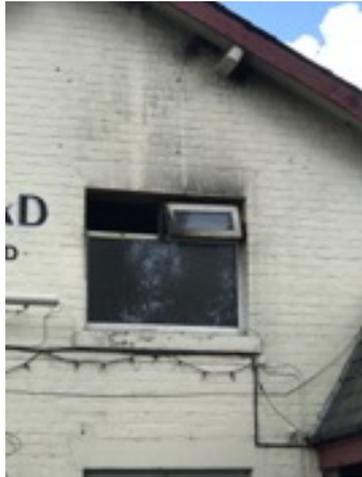
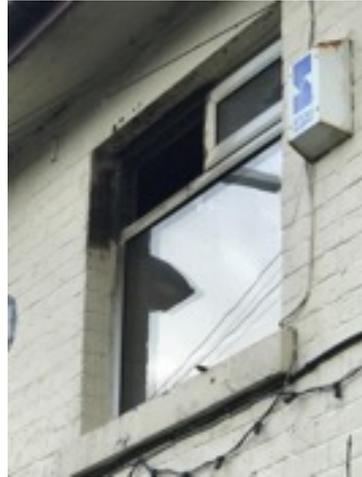
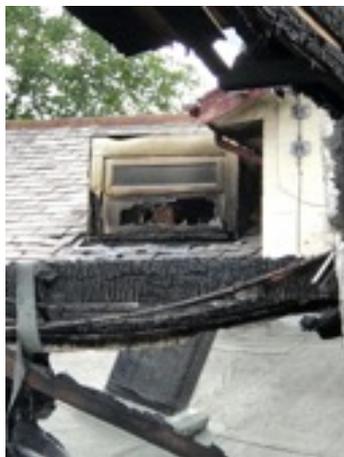
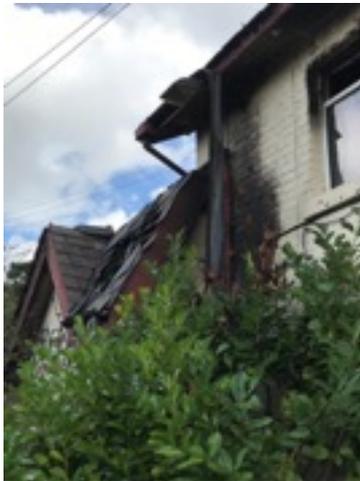
*PL. 10: Illustrating evidence of wide spread fire damage to throughout the first floor of the former Boars Head premises. Note first floor access deemed too dangerous at the time of inspection, however, extent of damage likely to reflect that of the ground floor illustrating in PL. 11 to follow.*

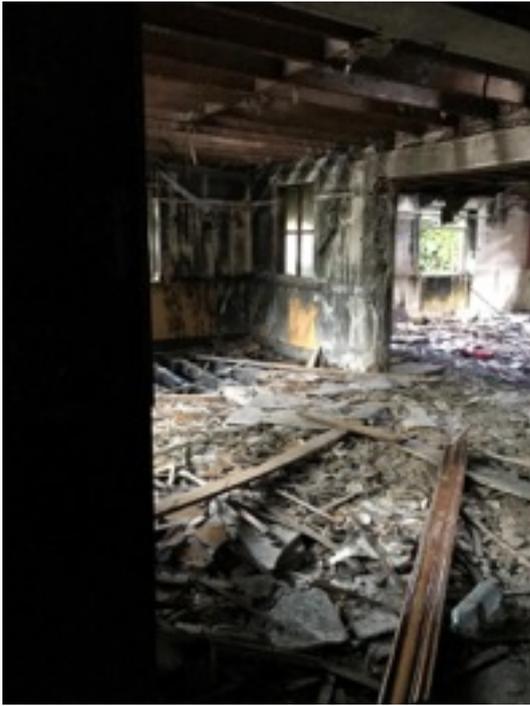
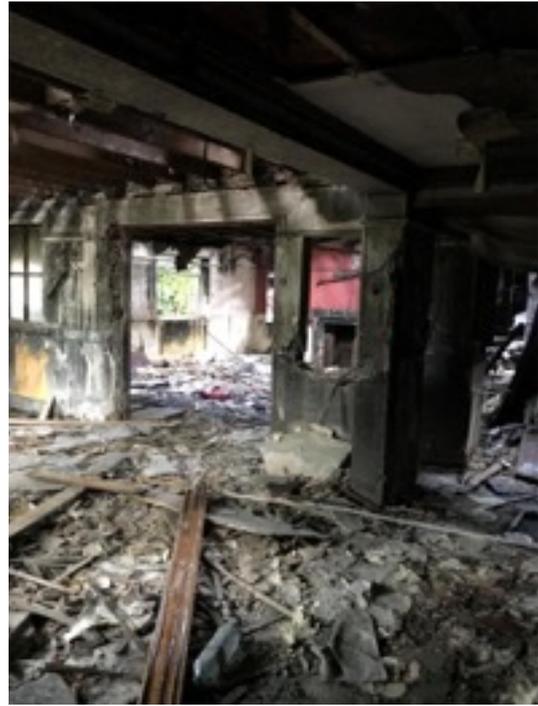
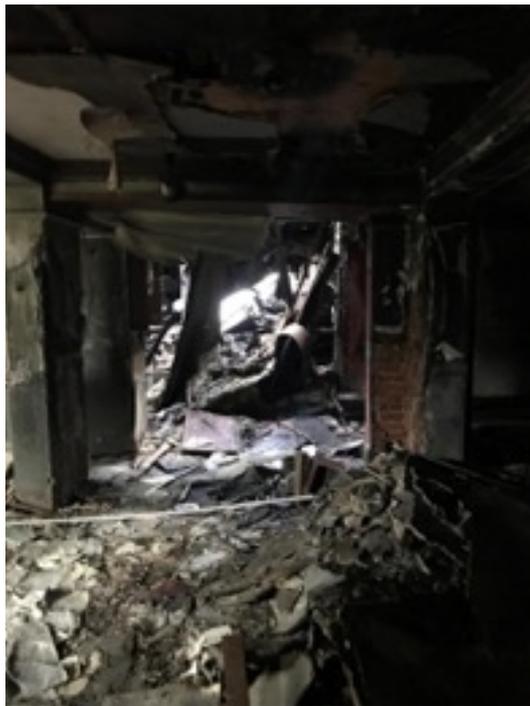
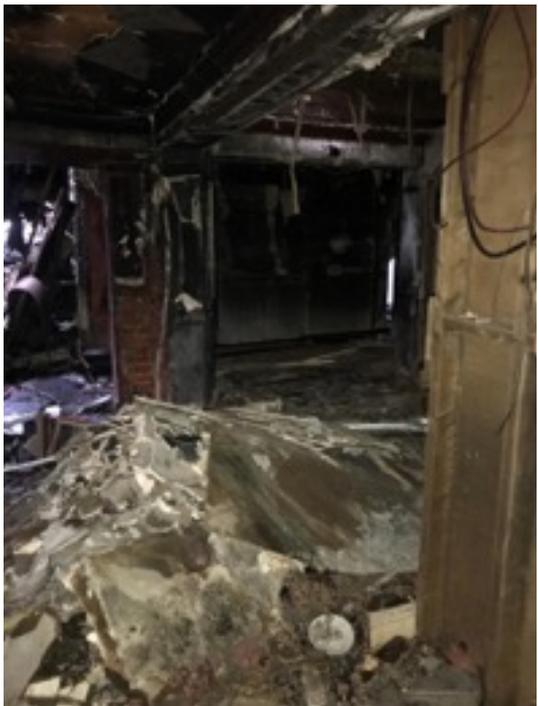
*PL. 11: Illustrating significant debris, dilapidation and dangerous conditions throughout the ground floor of the former Boar's Head premises recorded on the date of inspection.*
