Ecological Phase 1 Survey Report

Silver Hill Gardens on land at Connemara, Lightfoot Green Lane

October 2011

Project No & Title: BOW0017/353 Silver Hill Gardens on land at Connemara,
Lightfoot Green Lane.

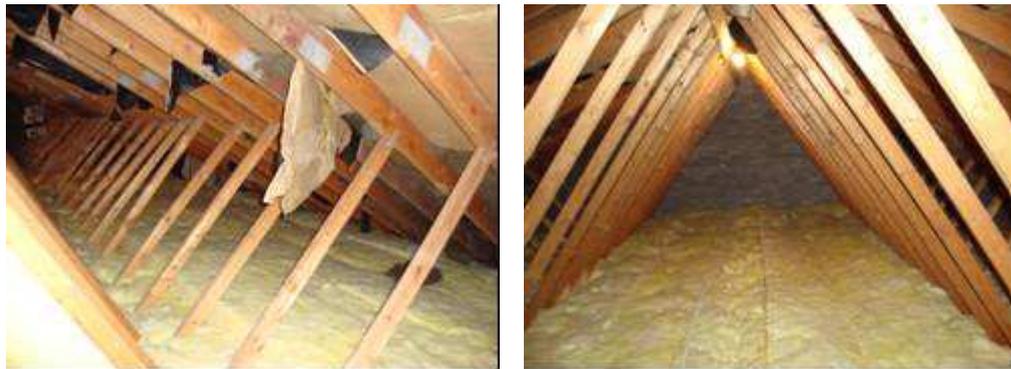
Plate 1 and Plate 2

- 3.34 Internally the house has an enclosed roof void, which is well insulated. The tiles are on timber batons, rafters and felt lining. Some of the roof lining is torn allowing potential access by bats into the roof void (plate 1). The walls are exposed brick work, with mortar work in good condition (plate 2). There are no other obvious access points within the internal roof void. No evidence of bat usage (bat droppings, staining or scratching) of the roof void was found.

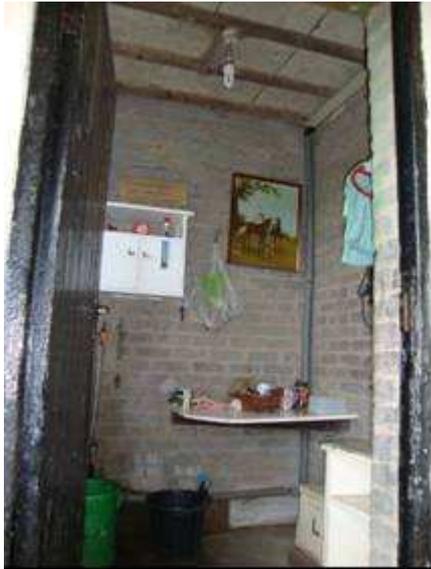
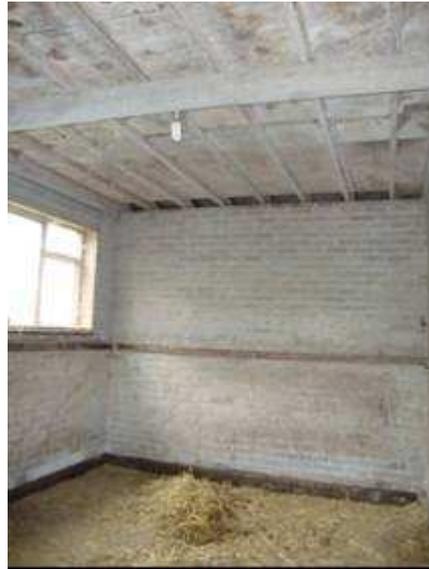
Plate 3 and Plate 4

- 3.35 Internally the stable block has an enclosed roof void, with tiles on batons and rafters with felt lining. The building is divided into five single storey rooms (plate 3). The roof void is enclosed, with small gaps along the northern edge where the ceiling meets the slope the roof (plate 4); inspection of the roof void was not possible due to an absence of loft access hatches. The exposed brick and mortar work was in good condition with limited opportunities for roosting bats. Access into the stables is possible through the open doorways and window panes. No evidence of bats was found during the internal inspection.

- 3.36 Following the internal and external inspection of the stable building, it was considered unsuitable for use by roosting bats and therefore the emergence and activity survey effort was concentrated on the house, which was considered more suitable. An Anabat detector was positioned within the stables for the duration of the survey to monitor any potential bat activity.

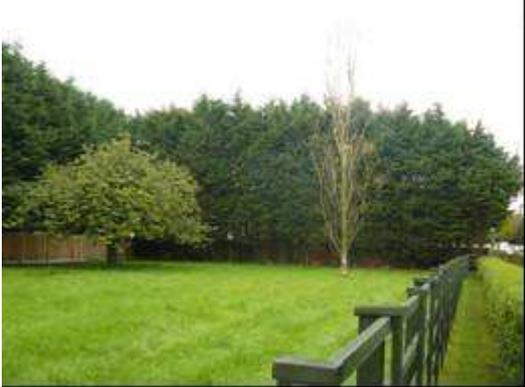
Target Note	Description	Photograph
1	<p>A tall <i>Leylandii cyperus</i> hedgerow that is species poor, dominated solely by one species. It was observed to support a range of small passerine birds during the survey, including blue tit, great tit, chaffinch, blackbird and robin and has high potential for nesting birds during the breeding season.</p>

- 4.8 Likewise, whilst the *Leylandii cyperus* hedgerow is species poor in terms of its botanical diversity, it provides a number of bird species with nesting habitat. It is recommended that this hedgerow is replaced with a hedgerow of native berry producing species, of local provenance, such as hawthorn, blackthorn, rowan, guelder rose, dog rose, elder and hazel.

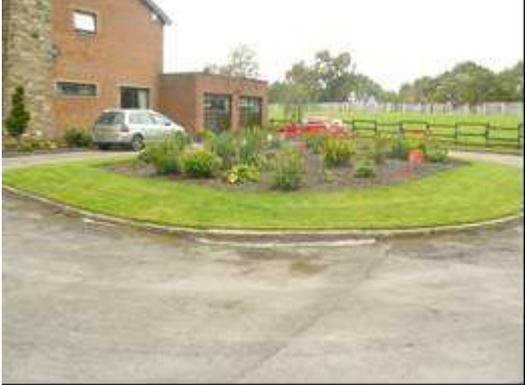
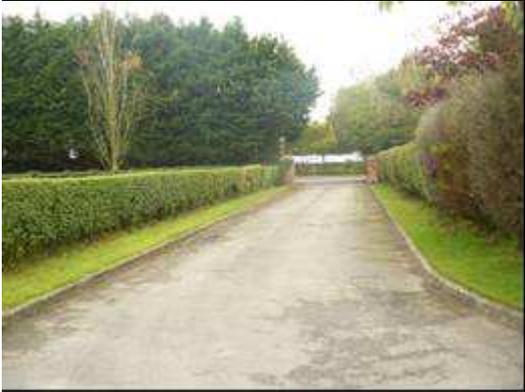
2	<p>An area of ornamental garden with introduced shrubs. It is species poor and has much bare ground, which provides suitable foraging habitat for birds such as blackbird and song thrush. It is however, heavily disturbed by pedestrians and dogs.</p> <p>Along the driveway are two privet (<i>Lingustrum ovalifolium</i>) hedgerows, which are species poor. The base of the hedgerow is more diverse with species such as ivy (<i>Hedera helix</i>), Yorkshire fog (<i>Holcus lanatus</i>), wood avens (<i>Geum urbanum</i>), creeping buttercup (<i>Ranunculus repens</i>), yarrow (<i>Achillea millefolium</i>), common mouse ear (<i>Cerastium fontanum</i>), horsetail (<i>Equisetum</i> sp.), broadleaved willowherb (<i>Epilobium montanum</i>), primrose (<i>Primula vulgaris</i>), dandelion (<i>Taraxacum</i> agg.), common nettle (<i>Urtica dioica</i>) and broadleaved dock (<i>Rumex obtusifolius</i>).</p>

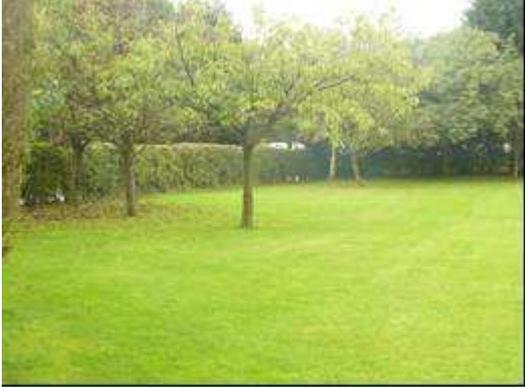
3	<p>An area of amenity grassland with scattered immature trees and one mature sycamore tree. The grassland is relatively species rich for amenity grassland, however, the species are commonly occurring, including; ribwort plantain (<i>Plantago lanceolata</i>), daisy (<i>Bellis perennis</i>), self heal (<i>Prunella vulgaris</i>), <i>Rhytidadelphus squarrosus</i>, annual meadow grass (<i>Poa annua</i>), perennial rye grass (<i>Lolium perenne</i>), dandelion, red fescue (<i>Festuca rubra</i>), common mouse ear, white clover (<i>Trifolium repens</i>) and bittercress (<i>Cardamine</i></p>

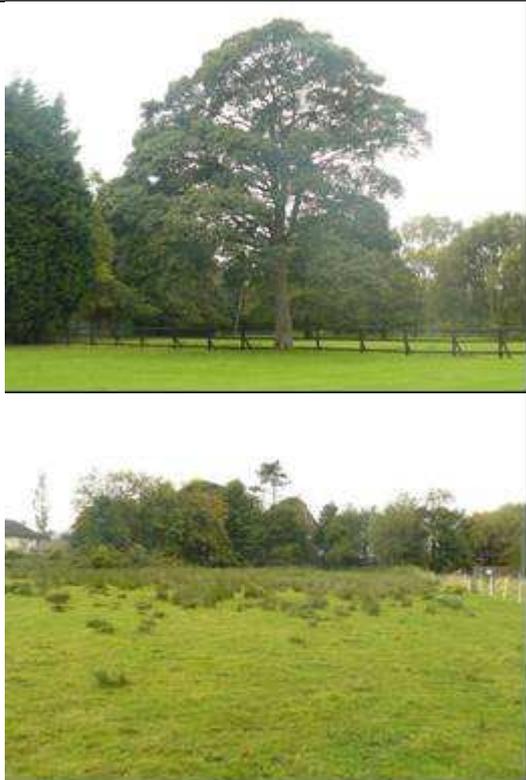
sp.).	
4	<p>Line of trees/outgrown hedgerow. Comprises oak (<i>Quercus robur</i>), sycamore (<i>Acer pseudoplatanus</i>), elder (<i>Sambucus nigra</i>), hawthorn (<i>Crataegus monogyna</i>), lime (<i>Tilia x europaea</i>), hornbeam (<i>Carpinus betulus</i>) and Scot's pine (<i>Pinus sylvestris</i>). Some mature trees are ivy clad and have crevices in the main trunk, providing potential habitat for roosting bats. There is evidence of rabbit activity beneath this feature. It also provides potential breeding habitat for nesting birds as well as habitat for small mammals including shrews, mice and voles.</p>

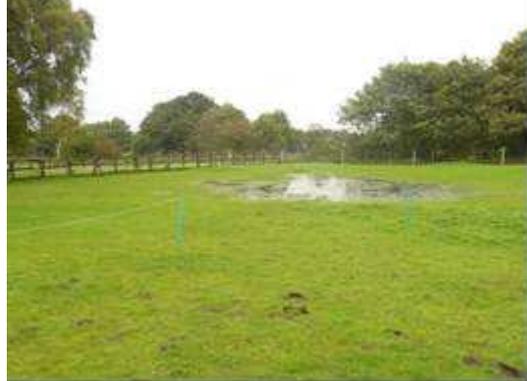
8	<p>A damp depression that was flooded at the time of the survey. It appears to dry out every year. It is small, has poor water quality, minor impacts by water fowl, and it is surrounded by moderate terrestrial habitat. A Habitat Suitability Index score for the pond, using 10 features of the pond to assess suitability for great crested newts, where 0 is unsuitable and 1 is optimal habitat, found that the score for the pond was 0.47, which indicates that the pond is poor for great crested newts.</p>

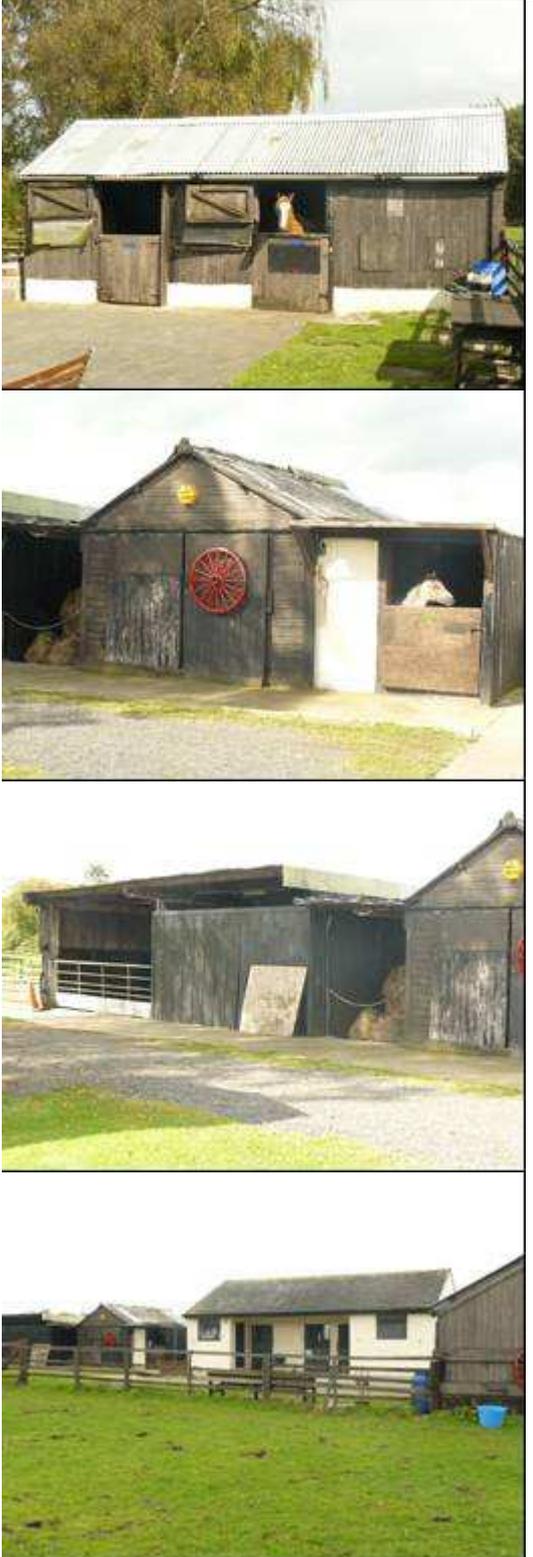
<p>9</p>	<p>Horse stables constructed from timber, timber and corrugated iron and rendered brick. The rendered building has potential for roosting bats beneath the slates and between the ridge tiles. No evidence of roosting bats was found during a detailed inspection. The timber sheds were not considered suitable for use by roosting bats due to the construction material which exposes bats to fluctuations in external conditions.</p> <p>Swallows are nesting within the rendered building. The young were still using the nest, but appeared to be in the process of fledging the nest.</p>

- 4.10 It is recommended that any works affecting potential bird nesting habitat, particularly the stable block, in which the swallows were observed to be nesting, and the hedgerows, scrub and scattered trees, should take place

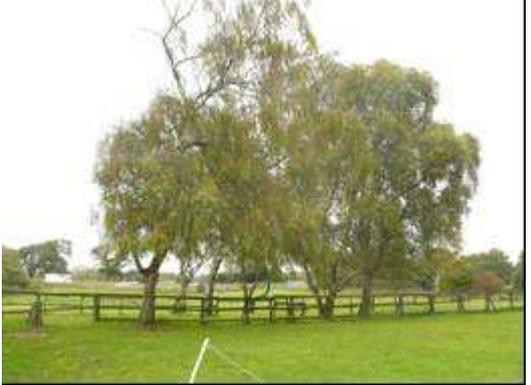
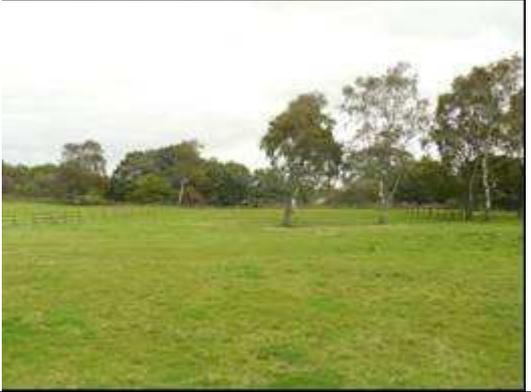
10	<p>Improved grassland with scattered silver birch (<i>Betula pendula</i>) trees. The trees are semi-mature and have limited potential features in which bats could roost.</p>

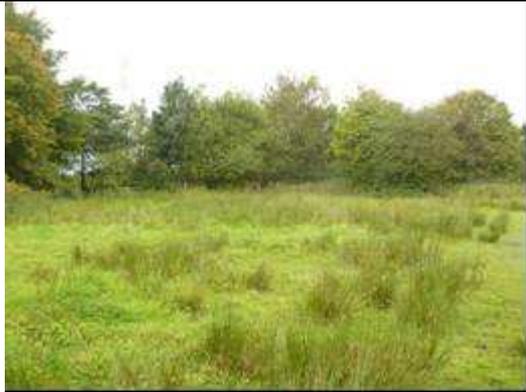
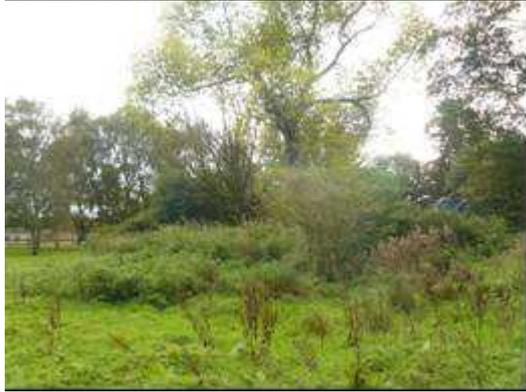
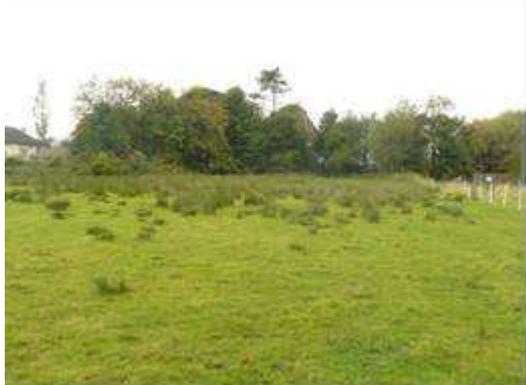
<p>12</p>	<p>Semi-improved grassland with an area of marshy grassland and scrub in the north western corner. Areas of the field have been selectively grazed, indicating a poor quality pasture. Species present in the grassland include; soft rush, compact rush (<i>Juncus conglomeratus</i>), creeping buttercup, spear thistle, creeping thistle, broadleaved dock, common sorrel, tufted hair grass, rough meadow grass, bent grass sp (<i>Agrostis</i> sp.), Timothy (<i>Phleum pratense</i>), perennial rye grass, dandelion, meadow buttercup, Yorkshire fog, cock's foot, false oat grass, red clover, white clover, self heal, <i>Rhytiadelphus squarrosus</i>, <i>Pleurozium schreberi</i>, <i>Hylocomium splendens</i>, common ragwort, scentless mayweed (<i>Tripleurospermum inodorum</i>), cleavers (<i>Galium aparine</i>), smooth sow thistle (<i>Sonchus oleraceus</i>), broadleaved willowherb and common nettle.</p> <p>A dead sycamore tree with large chunks of flaking bark is present in the south western corner of this field. It is of moderate risk for roosting bats due to the presence of the flaking bark.</p>

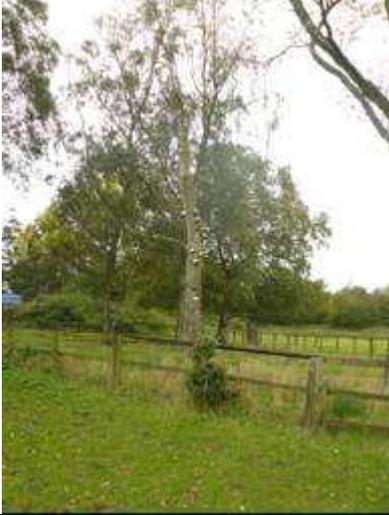
<p>13</p>	<p>Standing dead wood with evidence of use by woodpeckers. Standing dead wood is a valuable habitat for invertebrates and birds. This feature should be retained and if it cannot be retained in situ, it should be moved (strapped to a live tree) to a location in the western boundary with other mature trees.</p>

- 4.5 It is recommended that the standing dead wood feature (TN13) is retained and if it cannot be retained in situ, it should be moved (strapped to a live tree) to a location in the western boundary with other mature trees, thus maintaining its value to invertebrates and birds.

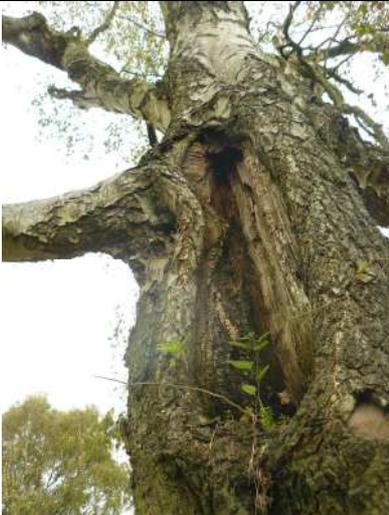
<p>14</p>	<p>A mature silver birch tree with a cavity running up the length of the trunk. It could provide potential roosting opportunities for bats; however, after close inspection no evidence of use by bats was identified.</p>

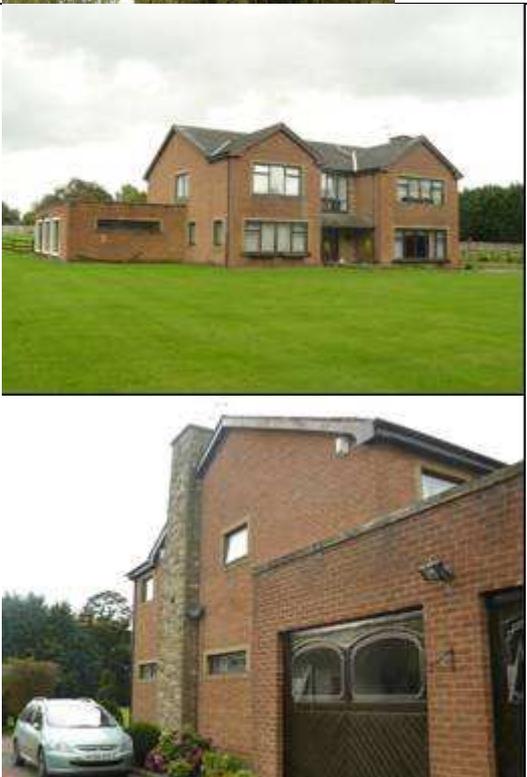
<p>15</p>	<p>The main house, located at the southern end of the site. It is a two storey brick built structure with a pitched, tiled roof. It has two, single storey flat roofed extensions, which include the garage and swimming pool. The mortar work is in good condition. The soffit, fascias and barge boards are timber and have some gaps present between the wall and boards and between the boards themselves. A wasp nest is present in the roof void, behind a fascia board in the western elevation.</p>
